Loss / Near Loss (L/NL)

Short Description : FCC Operators Sprayed and burned with hot oil

To Doug Fryer
Bruce Chinn
Mike Coyle
From Tim Potter / Mike Baer
Date 18 November 2010
Re Completed TapRoot® Investigation – IMPACT ERM #503

Event Title: Two operators burned during FCC cleanup

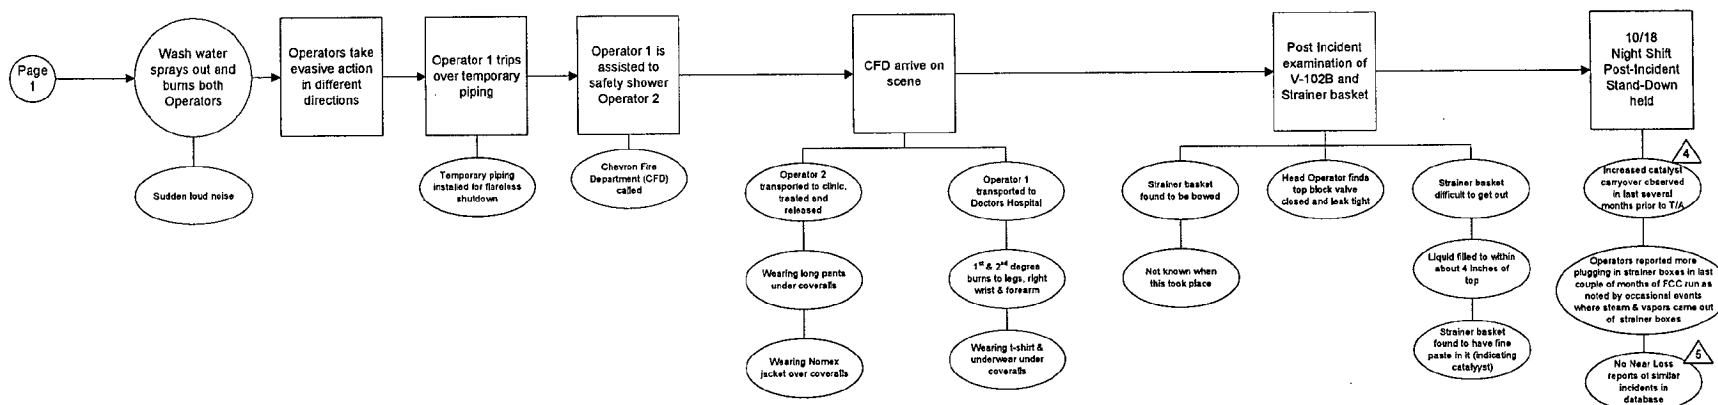
Events and Causal Factors Chart V-102B – Two Operators Sprayed with Hot Oil and Wash Water

Post incident examination of the V-102B strainer basket showed that the strainer basket was plugged with a mixture of catalyst, water and oily residue. The investigation team was told that catalyst fines, when mixed with water, may form a paste. A paste-like material was found on the seating surfaces at the top of the strainer basket. The investigation team hypothesized that the paste-like material plugged the strainer basket and the strainer basket seating surfaces, and together with the steam pressure, allowed the wash water to spray out while the strainer basket was being unlatched.

- The cleanup for the Turnaround caused an unexpected and unanticipated volume of catalyst to plug the strainer baskets;
- This is the first Turnaround where the strainer baskets were being used for cleaning the C-90 bottoms system strainers;
- The current written Job Aid did not address the unexpected and unanticipated volume of catalyst to the strainer basket;
- Operations personnel indicated that during the last few months of the FCC run they noticed more plugging in the strainer baskets, due to an increased amount of catalyst present. There were several events where steam and hot vapors came out of the strainer baskets during routine cleaning. These events were not reported until after this incident;
- Although expected by Refinery practices, operations personnel did not document near loss reports of similar incidents in the Richmond Refinery's Incident Reporting database.
